Assessment of trees at Camp Reserve,
Castlemaine

Arboricultural Impact Assessment

Prepared For: Mount Alexander
Shire Council
Corner Lyttleton and
Lloyd Streets
Castlemaine VIC
3450

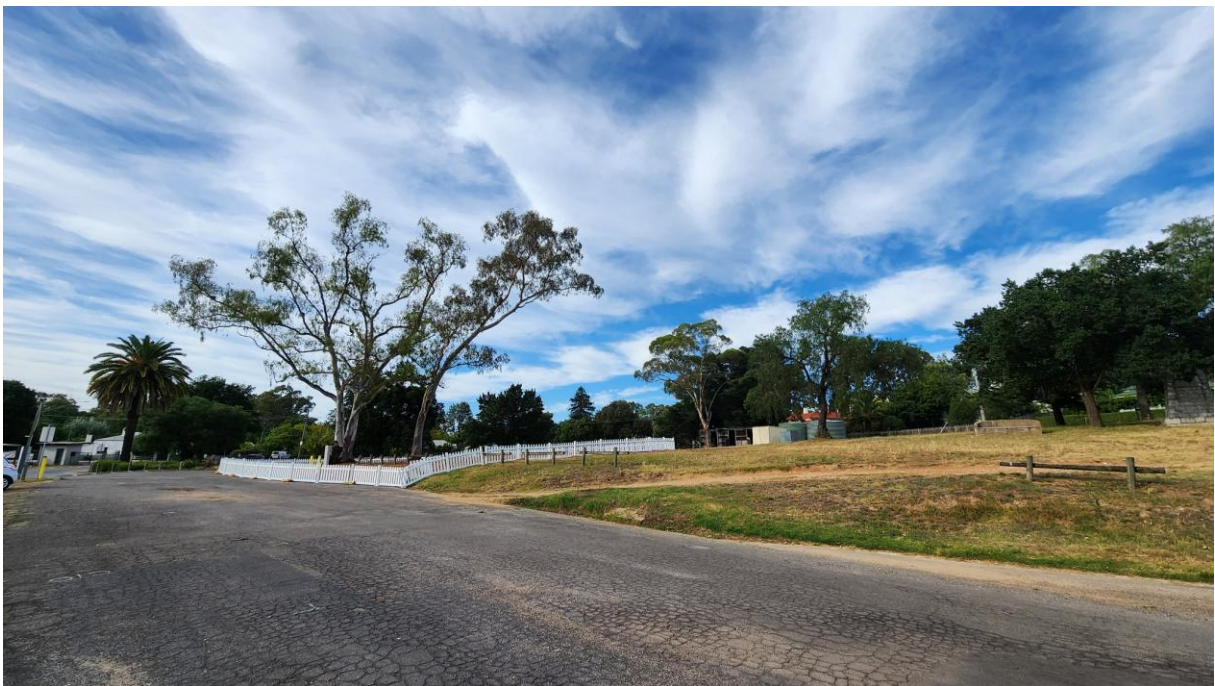
Figure 2: Southern section of the assessment area with Trees 3 & 4 surrounded by the white picket fence.

There are 3 species likely to be indigenous and remnant to the site. Trees 3 & 4 River Red Gum *Eucalyptus camaldulensis* and Tree 7 Yellow Box *Eucalyptus melliodora*. Trees 3 & 4 are centrally located within the reserve and have suffered decline in recent years (Figure 2).

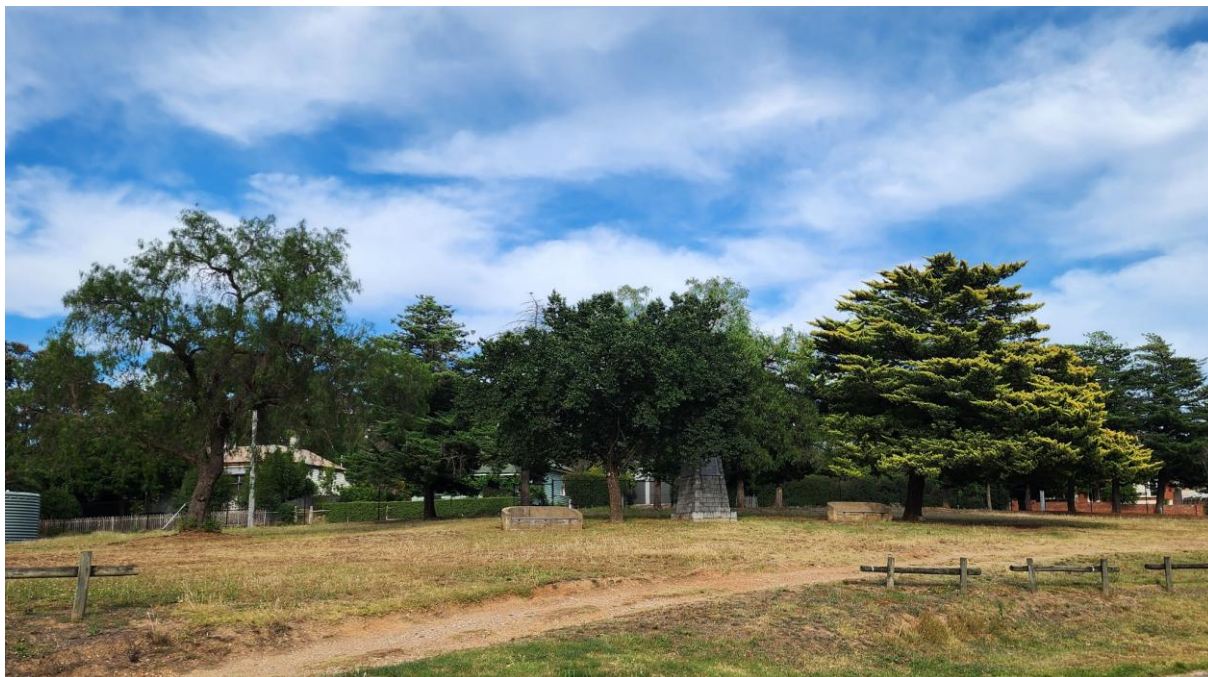
Figure 5: Trees 12-15 around the existing memorial.

Trees 12-15 were located around an existing war memorial and associated seating (Figure 5). They all had fair health and structure with long ULEs. Trees 14 & 15 both had broken branches.

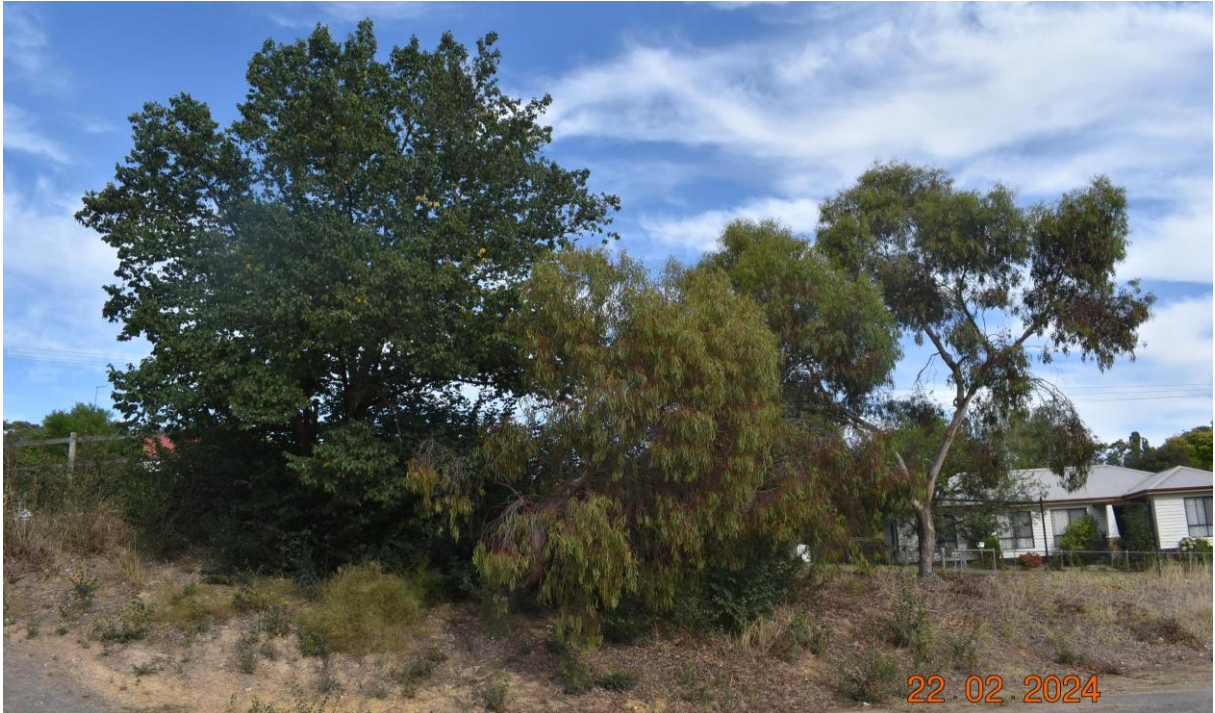
Figure 6: Trees 19-22.

- Trees 16 & 19-21 were a cultivated form of Yellow Gum *Eucalyptus leucoxylon* 'Rosea'. The trees were planted at the site and are likely to be approximately 20-30 years of age (Figure 6). They all had fair to good health and structure with ULEs of 11-20 years. This cultivated form of Yellow Gum often suffers branch failures in maturity.

- Tree 22 was a multistemmed Dutch Elm (Figure 6). It is unclear whether this tree was planted; however, given the multistemmed growth habit, it is possible that what exists today is just stump regrowth from a tree that was removed some time ago. Dutch Elm has a propensity to sucker and so the surrounding shoots are likely to be root suckers.

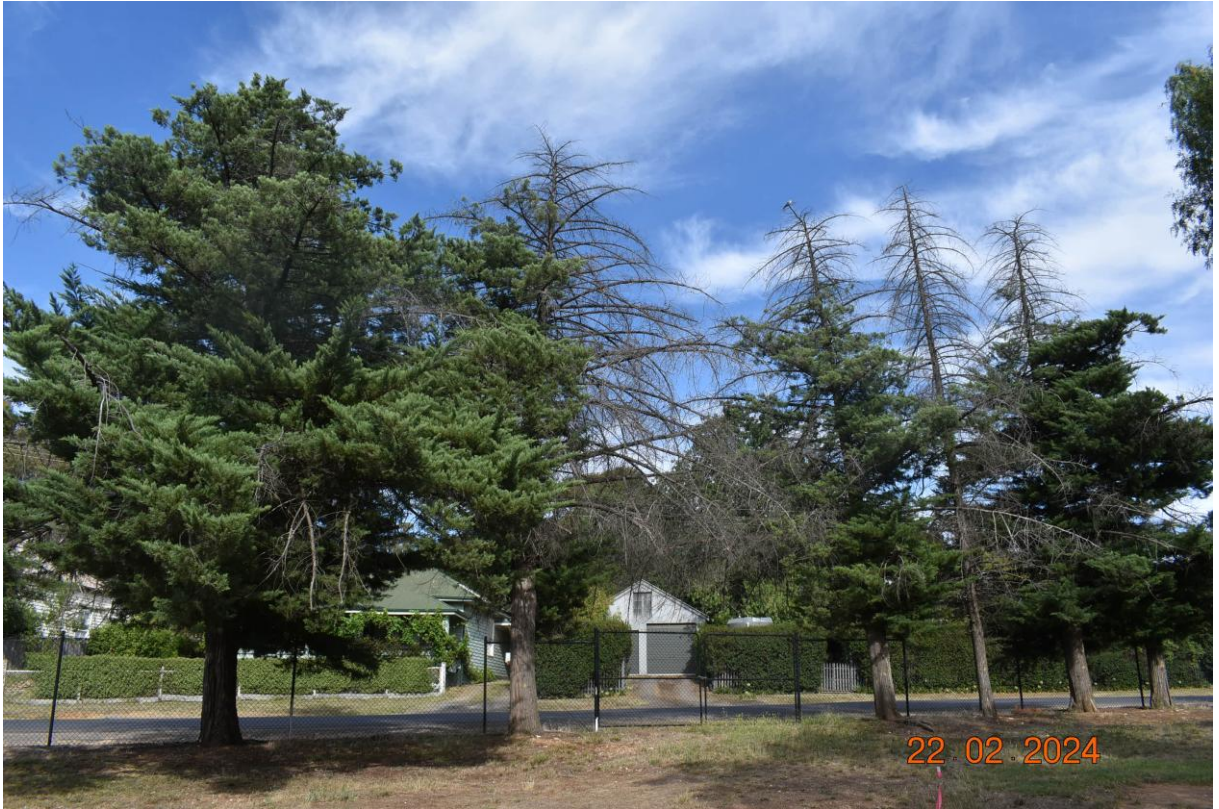
Figure 7: Trees 23-28.

Trees 8-11 & 23-37 were all Monterey Cypress growing along the fence line. Based off the alignment and aerial imagery, it appears that there was an entire row along the fence line; however, several have been removed over the years.

The trees were generally in a state of decline with deadwood and broken branches evident. They were all assessed with fair to poor health and structure with ULEs between 0 and 10 years. It is likely that the trees were suffering from Cypress Decline, a term given to a number of different fungal pathogens including Cypress Canker (*Seiridium* species), *Botryosphaeria*, *Phomopsis* and *Pestalotiopsis* species (DEDJTR 2017). These fungi can all cause dieback, particularly if the trees have been stressed.

The fungus kills the plant's vascular tissue, sometimes causing characteristic sunken, lens-shaped cankers and ringbarking. This interferes with the vascular system of the tree and eventually causes death above the wound. Generally, older trees are more susceptible but any tree is susceptible if in a stressed state (DEDJTR 2017, Sinclair & Lyon 2005).

These trees were in poor condition and should not be considered a constraint to the site.

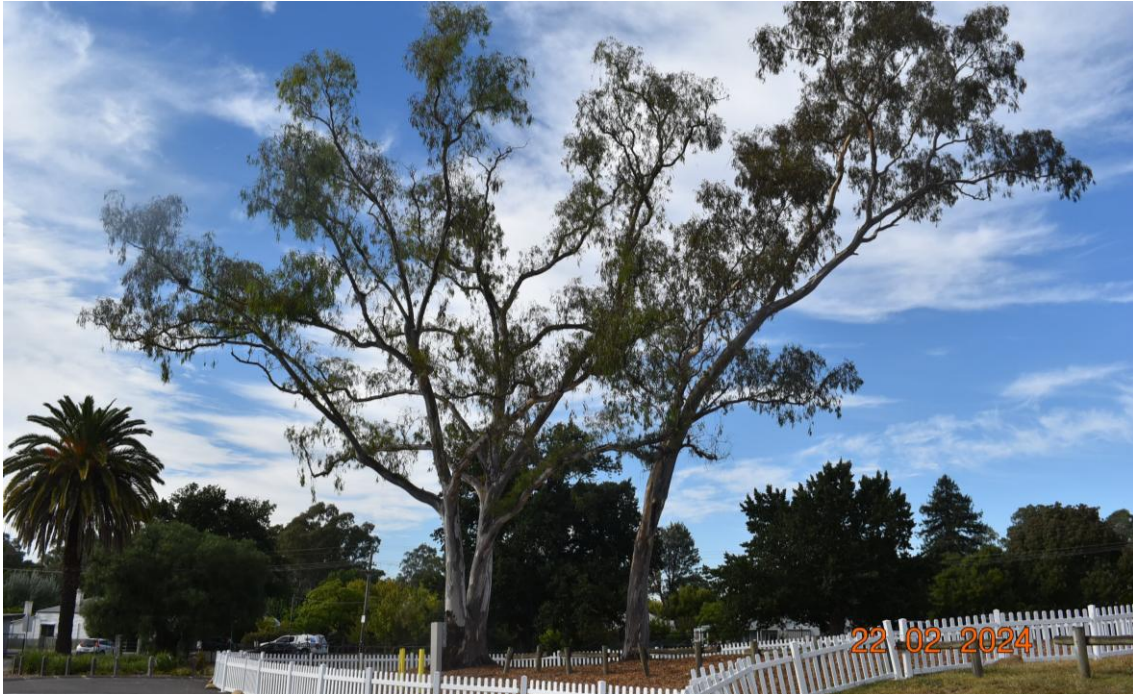
Figure 9: Trees 3 (left) & 4 (right).

Trees 3 & 4 were both large River Red Gum located within close proximity to each other, only a few metres from the asphalt at the southern end of the site (Figure 9). Tree 3 was the larger of the pair, Tree 4 had grown as a somewhat suppressed specimen with a phototropic lean.

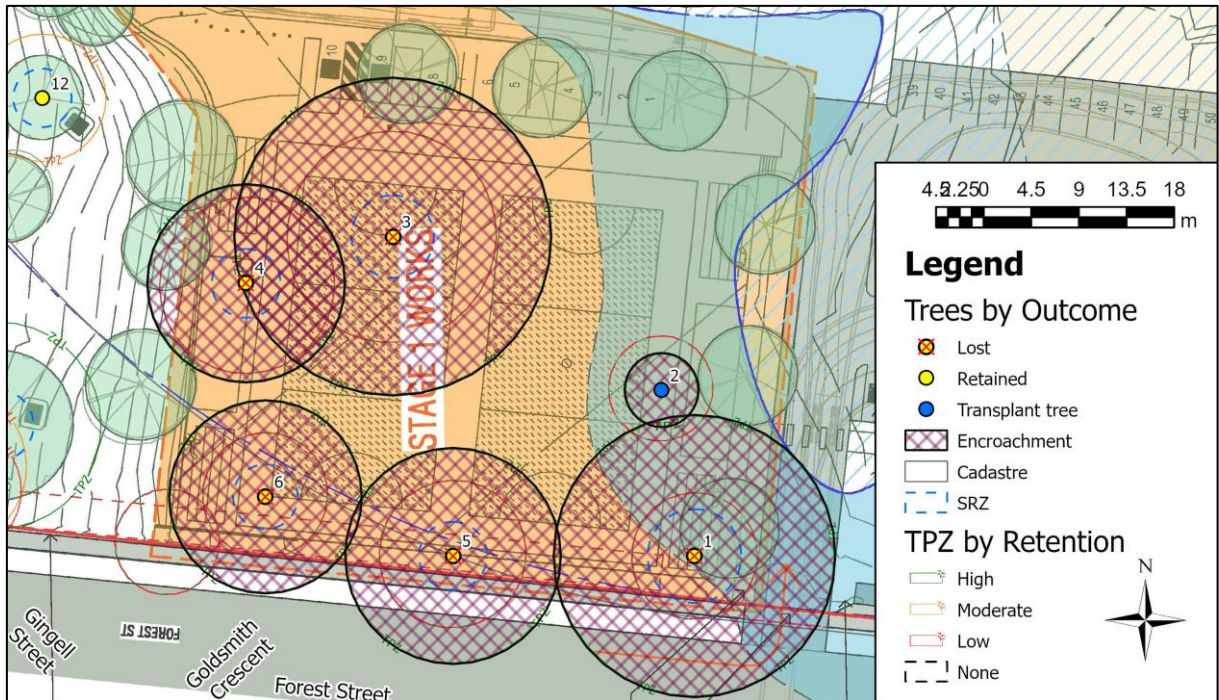
Figure 12: Tree impacts from proposed netball courts.

The proposed netball courts will result in the loss of Trees 1-6, all of which were assessed as high retention value (Figure 12). Tree 2 is a Canary Island Date Palm, and it is proposed to be transplanted into another area of the site. A significant redesign would be required if any of these trees required retention.

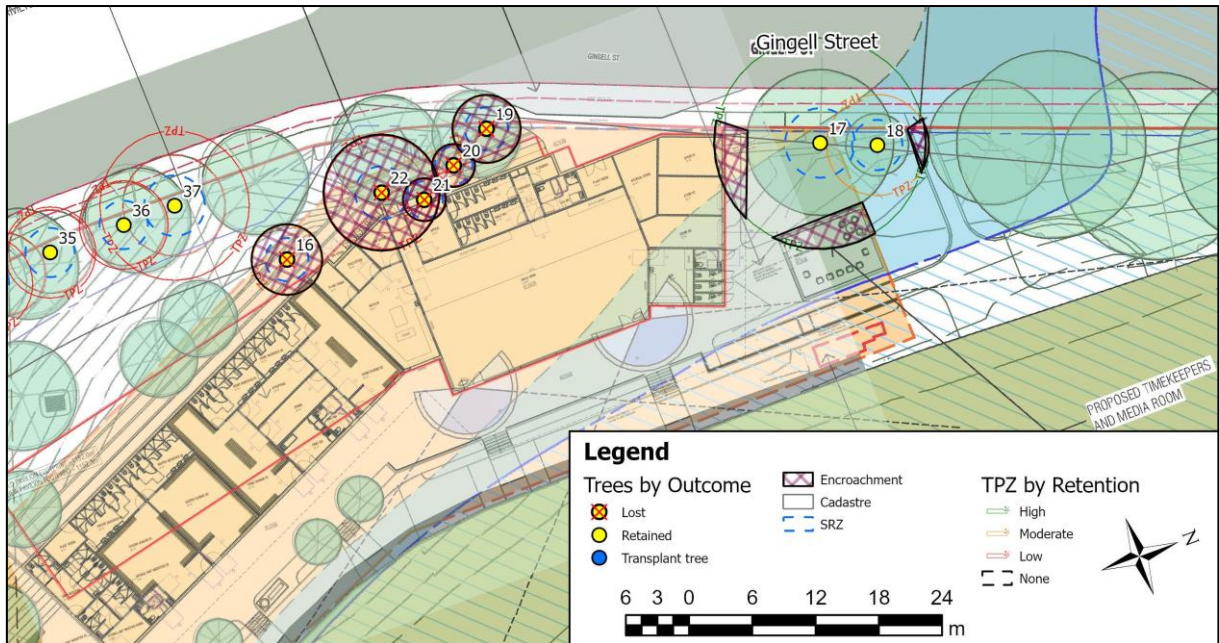
Figure 13: Tree impacts from the club rooms and surrounds.

Trees 16 & 19-22 will all be impacted by the proposed clubrooms and associated earthworks and require removal to facilitate the design (Figure 13). There are no simple design mitigation measures that could retain these trees, all of which were assessed with low or moderate retention values.

There will be 15% TPZ encroachment to Tree 17 from the proposed structures. The following comments are made regarding the likely impact to the tree:

1. Works for the timekeepers building will take place in an area that is highly compacted and likely to have few roots.
2. The encroachment on the south side of the tree will take place where there is an existing building proposed to be demolished.
3. The encroachment for the path should require minimal excavation.
4. English Oak tend to have a moderate level of tolerance to root disturbance.
5. A Tree Protection Management Plan must be developed for the site as part of the development works.
6. There must be no excavation within the TPZ for landscaping or other purposes.
7. Tree 17 can be retained.

There will be a 7% TPZ encroachment to Tree 18. This is considered minor encroachment, is beyond the SRZ and the tree will remain viable.
