Assessment of trees at Camp Reserve,
Castlemaine

Arboricultural Impact Assessment

Prepared For: Mount Alexander
Shire Council
Corner Lyttleton and
Lloyd Streets
Castlemaine VIC
3450

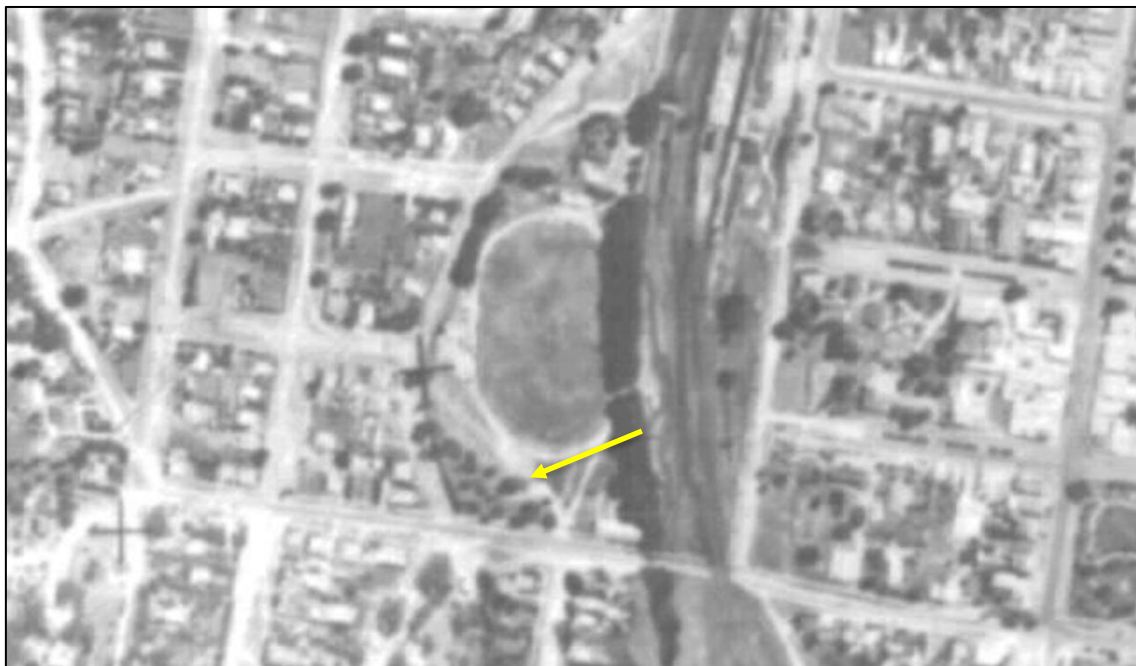
Figure 10: 1946 aerial imagery of Camp Reserve shows a large canopy in the location of Trees 3 & 4 (<https://mapshare.vic.gov.au/webmap/historical-photomaps>)

Aerial imagery from 1946 was reviewed to provide an estimate of the trees' age (Figure 10). 79 years ago, there was a significant patch of dark grey that is likely to have been the subject trees. Based on this, they would have been mature specimens when the photo was taken. An estimate of 150-200 years of age is provided for the trees.

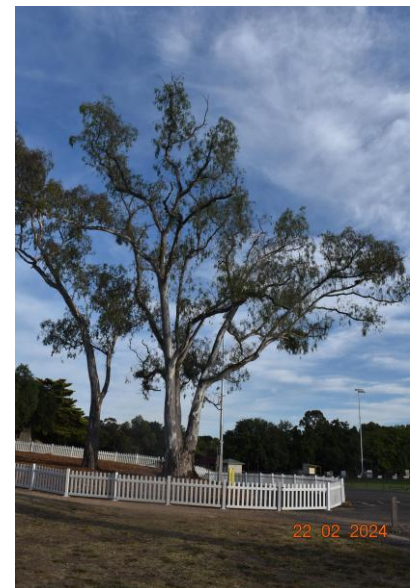
Tree ID 4

Encroachment Level: Major **Outcome:** Lost

Comments: tree has shown some response with new growth

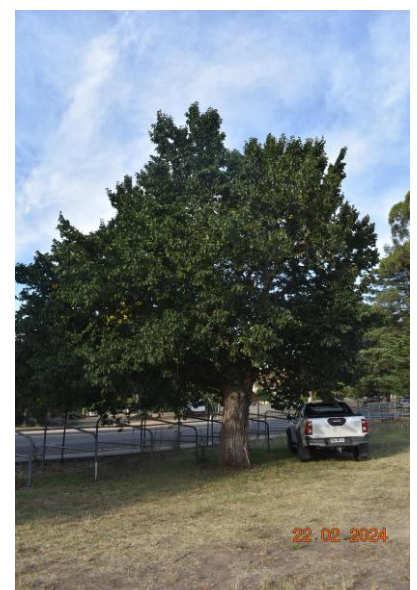
Tree ID 7

Comments: stables under western canopy

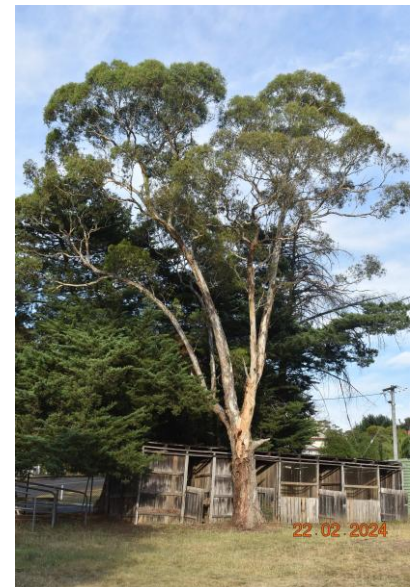
Tree ID 8

Comments: suppressed tree

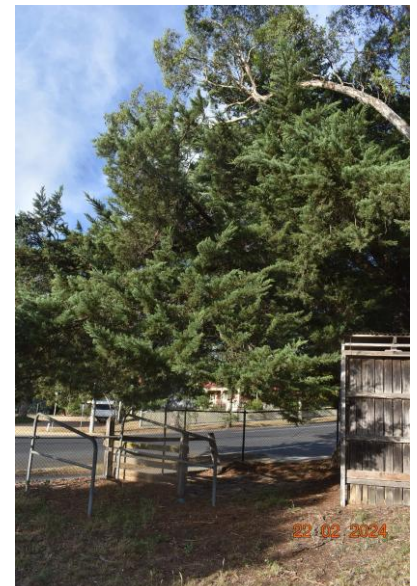
Tree ID 9

Comments: at rear of stable, restricted location

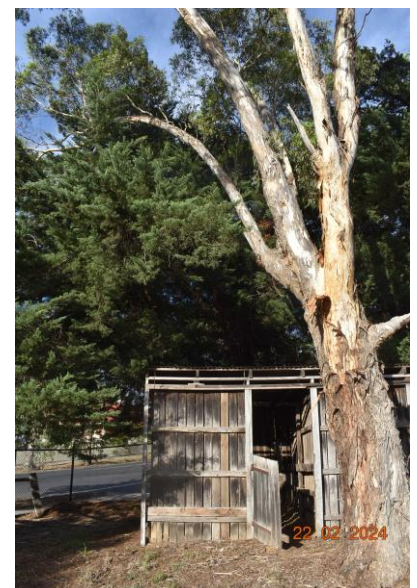
Tree ID 10

Common Name Monterey Cypress **Origin:** Exotic
Height (m): 14 **Health:** Poor
Width (m): 8 **Structure:** Fair
DBH (cm): 51 **ULE:** 6-10
Dia. @ base (cm): 61
Age Class: Over mature
Retention Value: Moderate
TPZ Radius (m): 6.12 **TPZ encroachment %:**
SRZ Radius (m): 2.7 **SRZ intrusion:** No
Encroachment Level: None **Outcome:** Retained
Comments: at rear of stable, restricted location

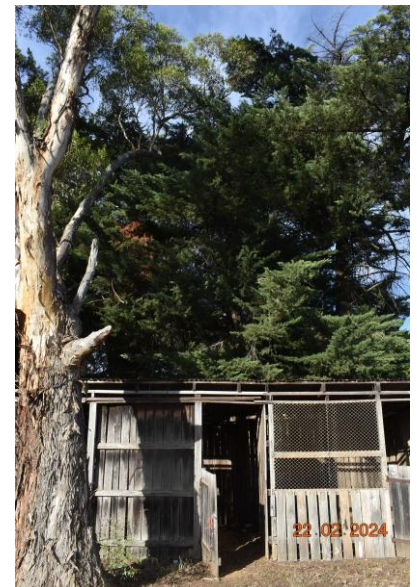
Tree ID 11

Common Name Monterey Cypress **Origin:** Exotic
Height (m): 14 **Health:** Poor
Width (m): 8 **Structure:** Fair
DBH (cm): 51 **ULE:** 1-5
Dia. @ base (cm): 63
Age Class: Over mature
Retention Value: Low
TPZ Radius (m): 6.12 **TPZ encroachment %:**
SRZ Radius (m): 2.7 **SRZ intrusion:** No
Encroachment Level: None **Outcome:** Retained
Comments: at rear of stable, restricted location

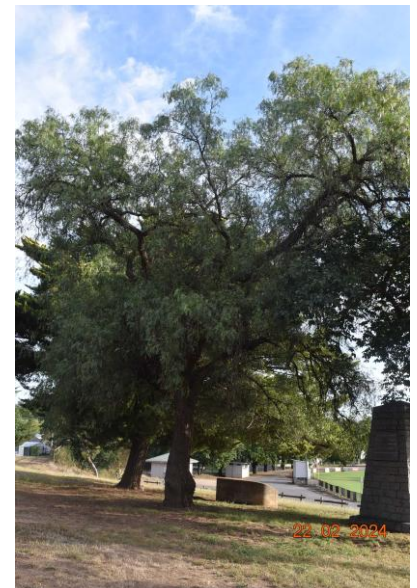
Tree ID 15

Comments: tap is embedded in trunk, cultivar is 'Horizontalis Aurea'

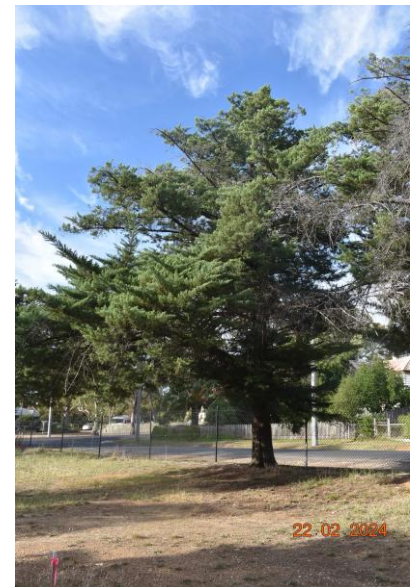
Tree ID 17

Common Name Monterey Cypress **Origin:** Exotic
Height (m): 11 **Health:** Very poor
Width (m): 5 **Structure:** Poor
DBH (cm): 47 **ULE:** 1-5
Dia. @ base (cm): 59
Age Class: Severe decline
Retention Value: Low
TPZ Radius (m): 5.64 **TPZ encroachment %:**
SRZ Radius (m): 2.7 **SRZ intrusion:** No
Encroachment Level: None **Outcome:** Retained

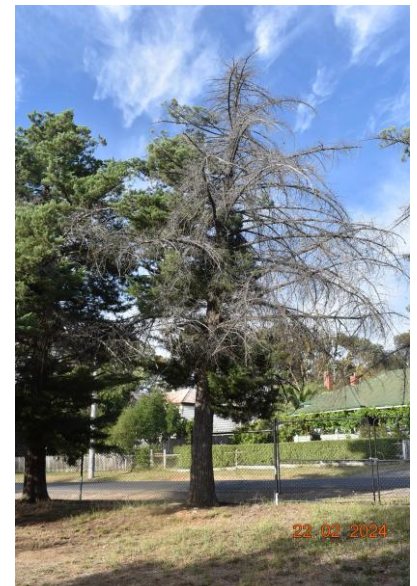
Tree ID 18

Common Name Monterey Cypress **Origin:** Exotic
Height (m): 11 **Health:** Poor
Width (m): 5 **Structure:** Poor
DBH (cm): 40 **ULE:** 0
Dia. @ base (cm): 47
Age Class: Severe decline
Retention Value: None
TPZ Radius (m): 4.8 **TPZ encroachment %:**
SRZ Radius (m): 2.4 **SRZ intrusion:** No
Encroachment Level: None **Outcome:** Retained

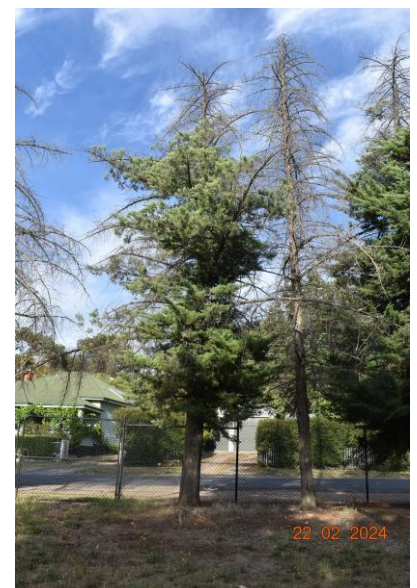
Tree ID 19

Common Name Monterey Cypress **Origin:** Exotic
Height (m): 11 **Health:** Dead
Width (m): 4 **Structure:** Very Poor
DBH (cm): 23 **ULE:** 0
Dia. @ base (cm): 30
Age Class: Severe decline
Retention Value: None
TPZ Radius (m): 2.76 **TPZ encroachment %:**
SRZ Radius (m): 2.0 **SRZ intrusion:** No
Encroachment Level: None **Outcome:** Retained

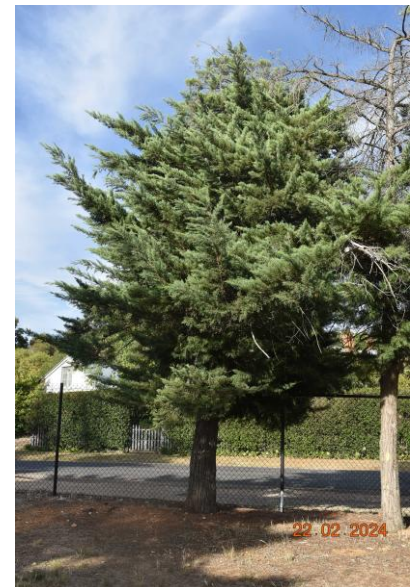
Tree ID 23

Common Name Monterey Cypress **Origin:** Exotic
Height (m): 7 **Health:** Very poor
Width (m): 5 **Structure:** Poor
DBH (cm): 23 **ULE:** 0
Dia. @ base (cm): 30
Age Class: Severe decline
Retention Value: Low
TPZ Radius (m): 2.76 **TPZ encroachment %:**
SRZ Radius (m): 2.0 **SRZ intrusion:** No
Encroachment Level: None **Outcome:** Retained

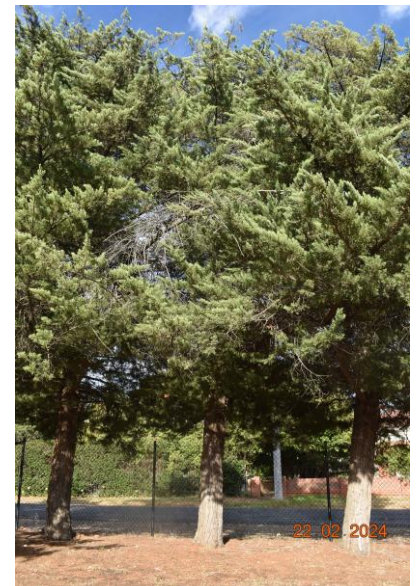
Common Name Monterey Cypress **Origin:** Exotic
Height (m): 10 **Health:** Fair
Width (m): 6 **Structure:** Fair
DBH (cm): 37 **ULE:** 6-10
Dia. @ base (cm): 45
Age Class: Mature
Retention Value: Low
TPZ Radius (m): 4.44 **TPZ encroachment %:**
SRZ Radius (m): 2.4 **SRZ intrusion:** No
Encroachment Level: None **Outcome:** Retained

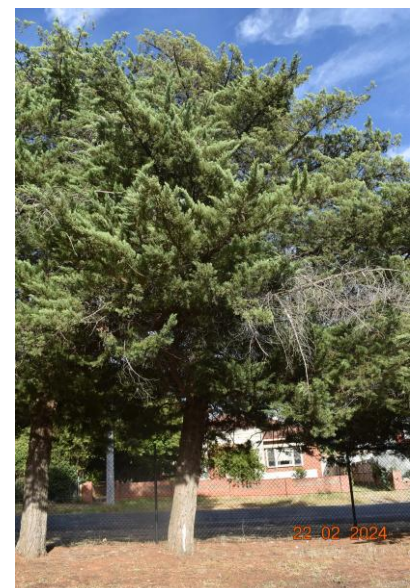
Tree ID 27

Common Name Monterey Cypress **Origin:** Exotic
Height (m): 9 **Health:** Fair
Width (m): 7 **Structure:** Fair
DBH (cm): 39 **ULE:** 6-10
Dia. @ base (cm): 43
Age Class: Mature
Retention Value: Low
TPZ Radius (m): 4.68 **TPZ encroachment %:**
SRZ Radius (m): 2.3 **SRZ intrusion:** No
Encroachment Level: None **Outcome:** Retained

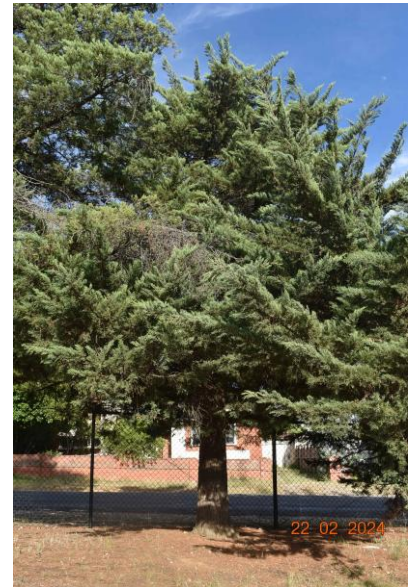
Tree ID 28

Common Name Monterey Cypress **Origin:** Exotic
Height (m): 7 **Health:** Fair
Width (m): 7 **Structure:** Fair
DBH (cm): 37 **ULE:** 6-10
Dia. @ base (cm): 44
Age Class: Mature
Retention Value: Low
TPZ Radius (m): 4.44 **TPZ encroachment %:**
SRZ Radius (m): 2.3 **SRZ intrusion:** No
Encroachment Level: None **Outcome:** Retained

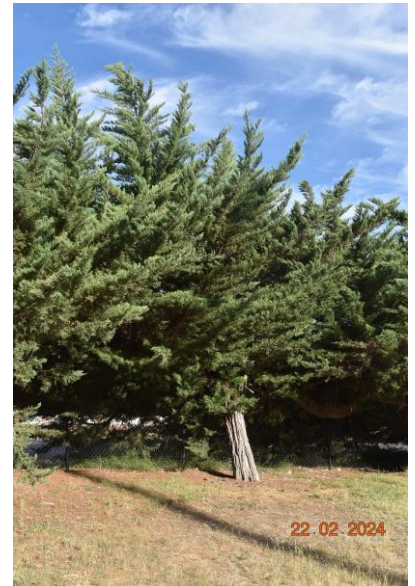
Tree ID 29

Common Name Monterey Cypress **Origin:** Exotic
Height (m): 6 **Health:** Fair
Width (m): 7 **Structure:** Poor
DBH (cm): 36 **ULE:** 1-5
Dia. @ base (cm): 42
Age Class: Mature
Retention Value: Low
TPZ Radius (m): 4.32 **TPZ encroachment %:**
SRZ Radius (m): 2.3 **SRZ intrusion:** No
Encroachment Level: None **Outcome:** Retained

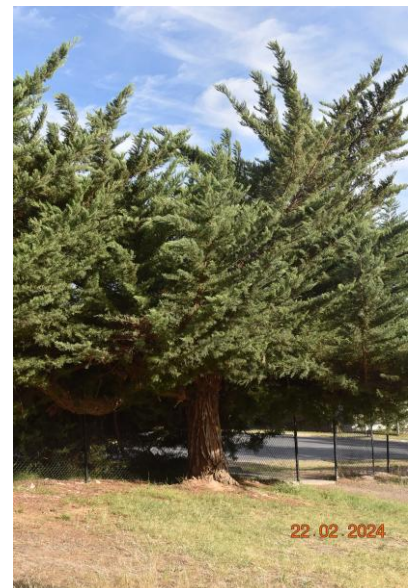
Tree ID 30

Common Name Monterey Cypress **Origin:** Exotic
Height (m): 6 **Health:** Fair
Width (m): 8 **Structure:** Poor
DBH (cm): 60 **ULE:** 1-5
Dia. @ base (cm): 72
Age Class: Mature
Retention Value: Low
TPZ Radius (m): 7.2 **TPZ encroachment %:**
SRZ Radius (m): 2.9 **SRZ intrusion:** No
Encroachment Level: None **Outcome:** Retained

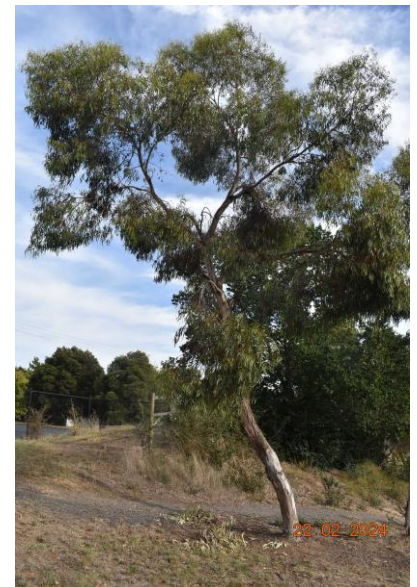
Tree ID 31

Height (m): 8 **Health:** Good

Width (m): 5 **Structure:** Fair

DBH (cm): 28 **ULE:** 11-20

TPZ Radius (m): 3.36 **TPZ encroachment %:**100

SRZ Radius (m): 2.1 **SRZ intrusion:** Yes

Encroachment Level: Major **Outcome:** Lost

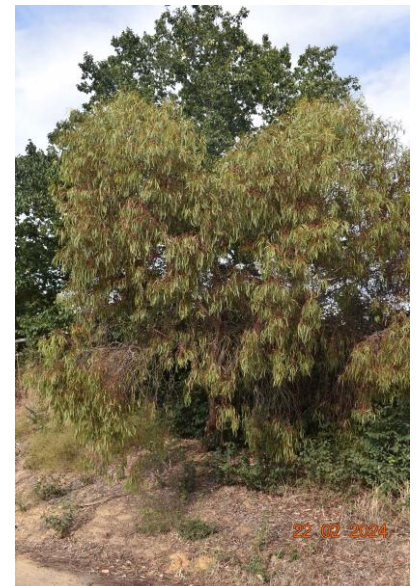
Tree ID 32

Encroachment Level: Major **Outcome:** Lost

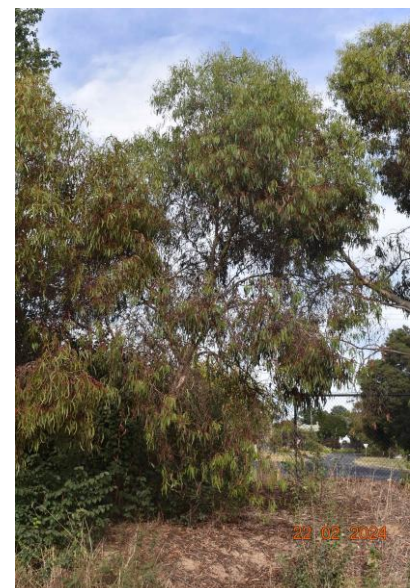
Tree ID 33

Encroachment Level: Major **Outcome:** Lost

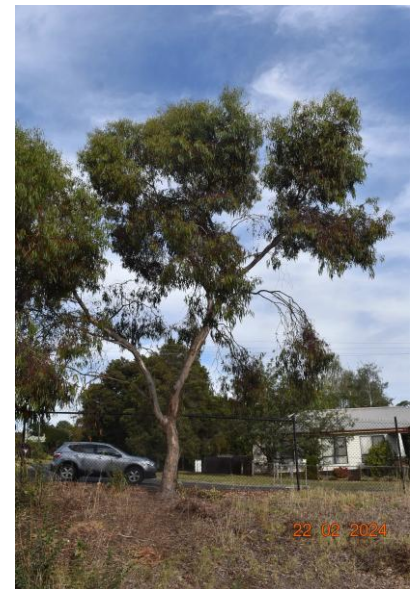
Tree ID 34

Encroachment Level: Major **Outcome:** Lost

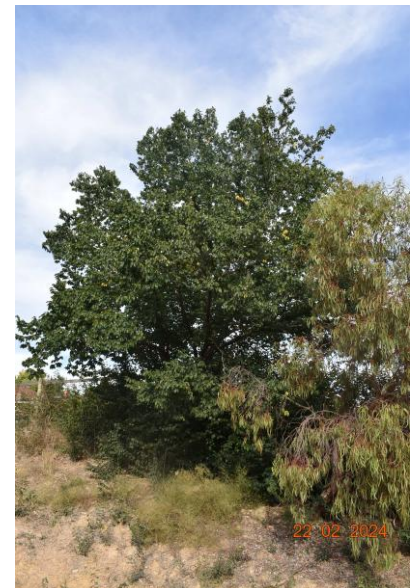
Tree ID 35

Encroachment Level: Major **Outcome:** Lost

Comments: masses of suckers beneath

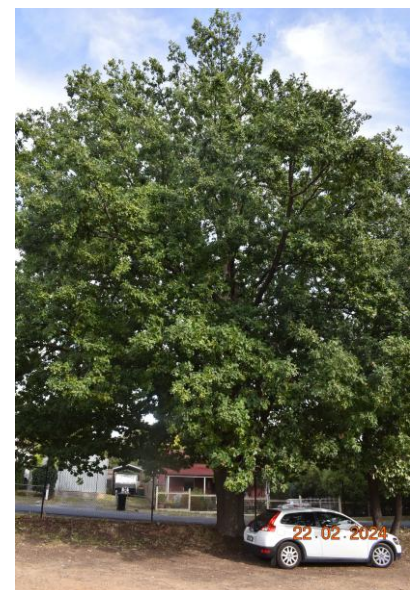
Tree ID 36

Encroachment Level: Major **Outcome:** Retained

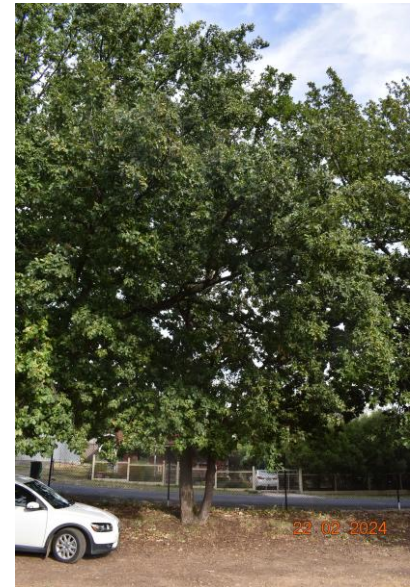
Tree ID 37

Encroachment Level: Minor **Outcome:** Retained
